5.5 Wind Control Devices with suppression WDF 5

The fifth experiment in the series was conducted to examine the impact of wind on the structure fire and quantify the impact of the small wind control device. It also examined the impact of a 30 gpm water flow to be applied in conjunction with the WCD deployment. The experimental preparations were made as described in Section 4. The fan speed used in this experiment was 1500 RPM, which provided a 3.0 m/s to 4.0 m/s (7 mph to 9 mph) wind speed at the window opening. A trash container fuel package was ignited remotely with an electric match to start the experiment at Time = 0 s. A time line of the experiment is presented in Table 5.5-1. The results for the experiment are presented in the following sections: observations, heat release rate, temperature, heat flux, pressure, velocity, and gas concentrations. An uncertainty range marker is included in each graph.

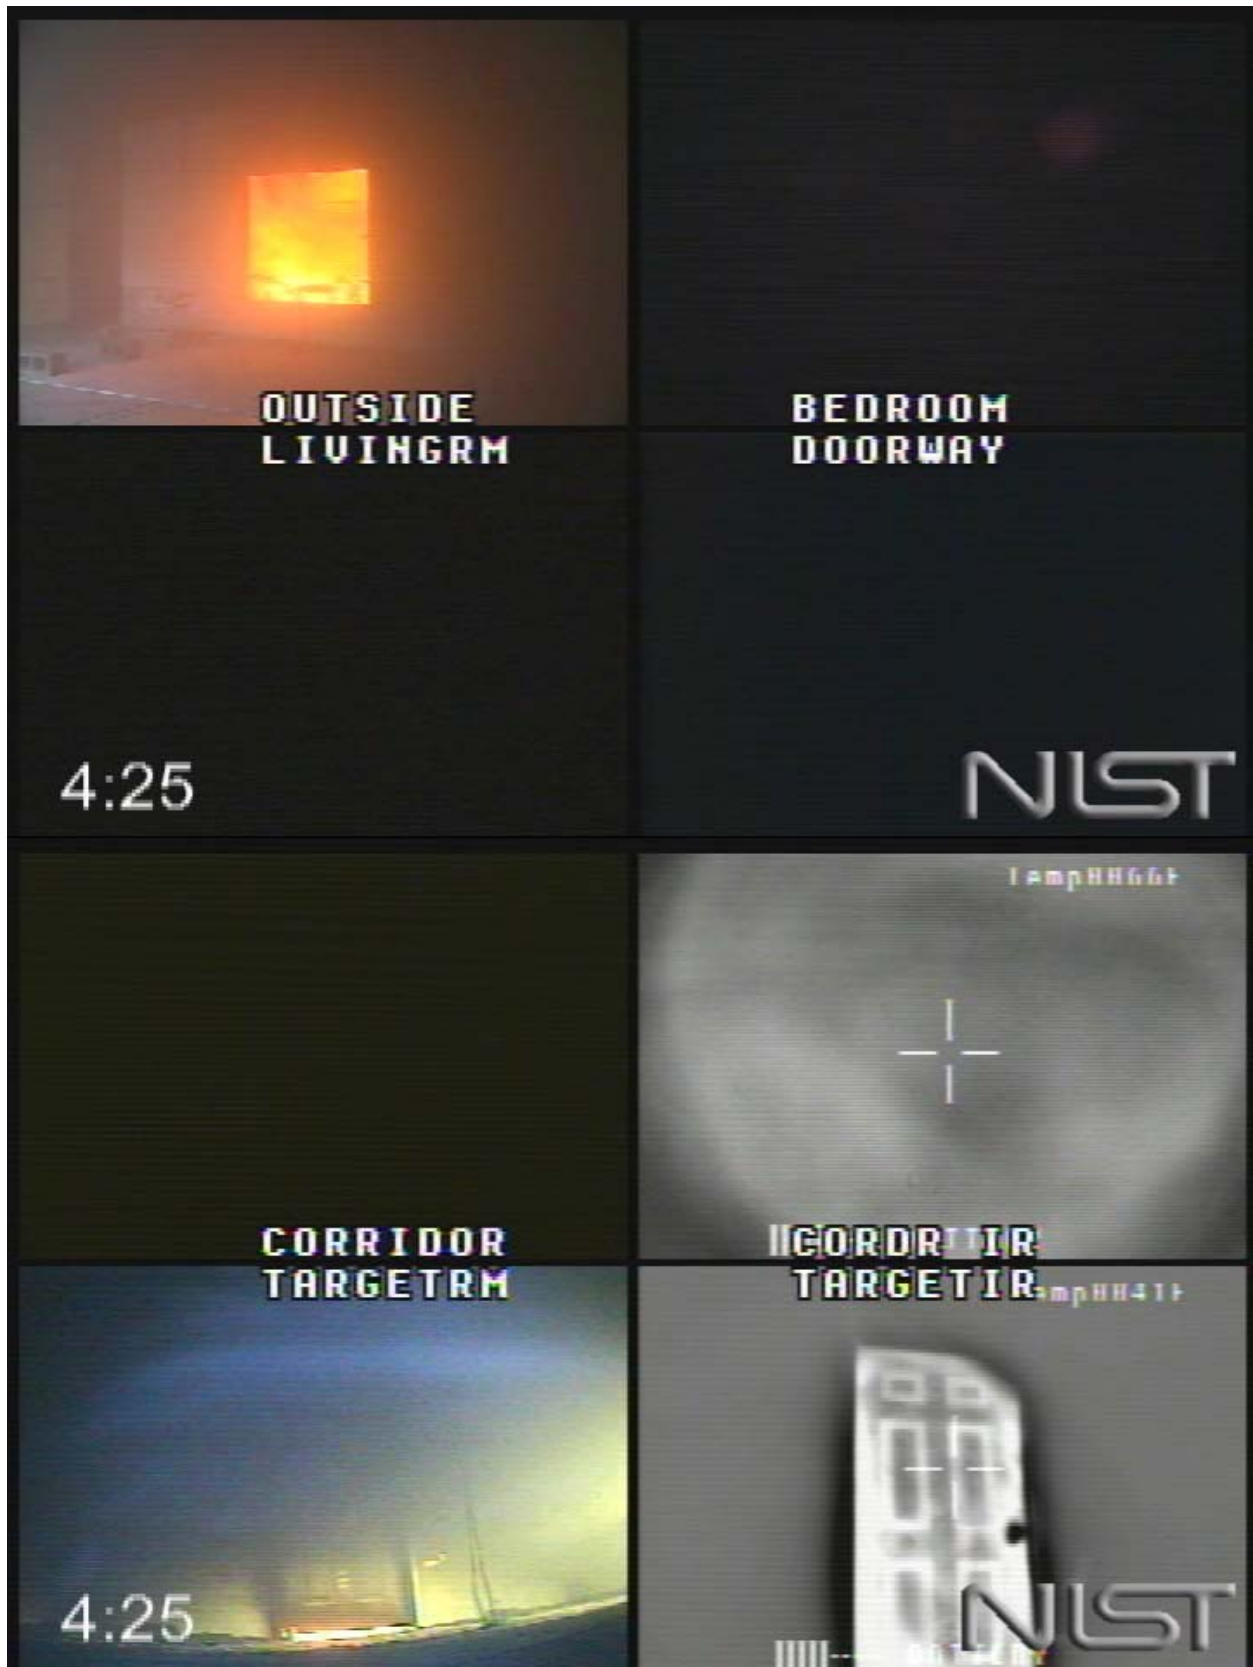
Figure 5.6.1-7. Experiment 6, 240 s after ignition.

Figure 5.6.1-7 shows the conditions at 240 s after ignition. Flames were pulsing out of the window opening. Smoke was obscuring the views in the bedroom, living room and corridor. The amount of heat entering the hallway has caused the image from the corridor IR camera to deteriorate substantially. The visual image in the target room showed flames continuing to burn under the door. The visibility at the lower layer in the target room remained good.

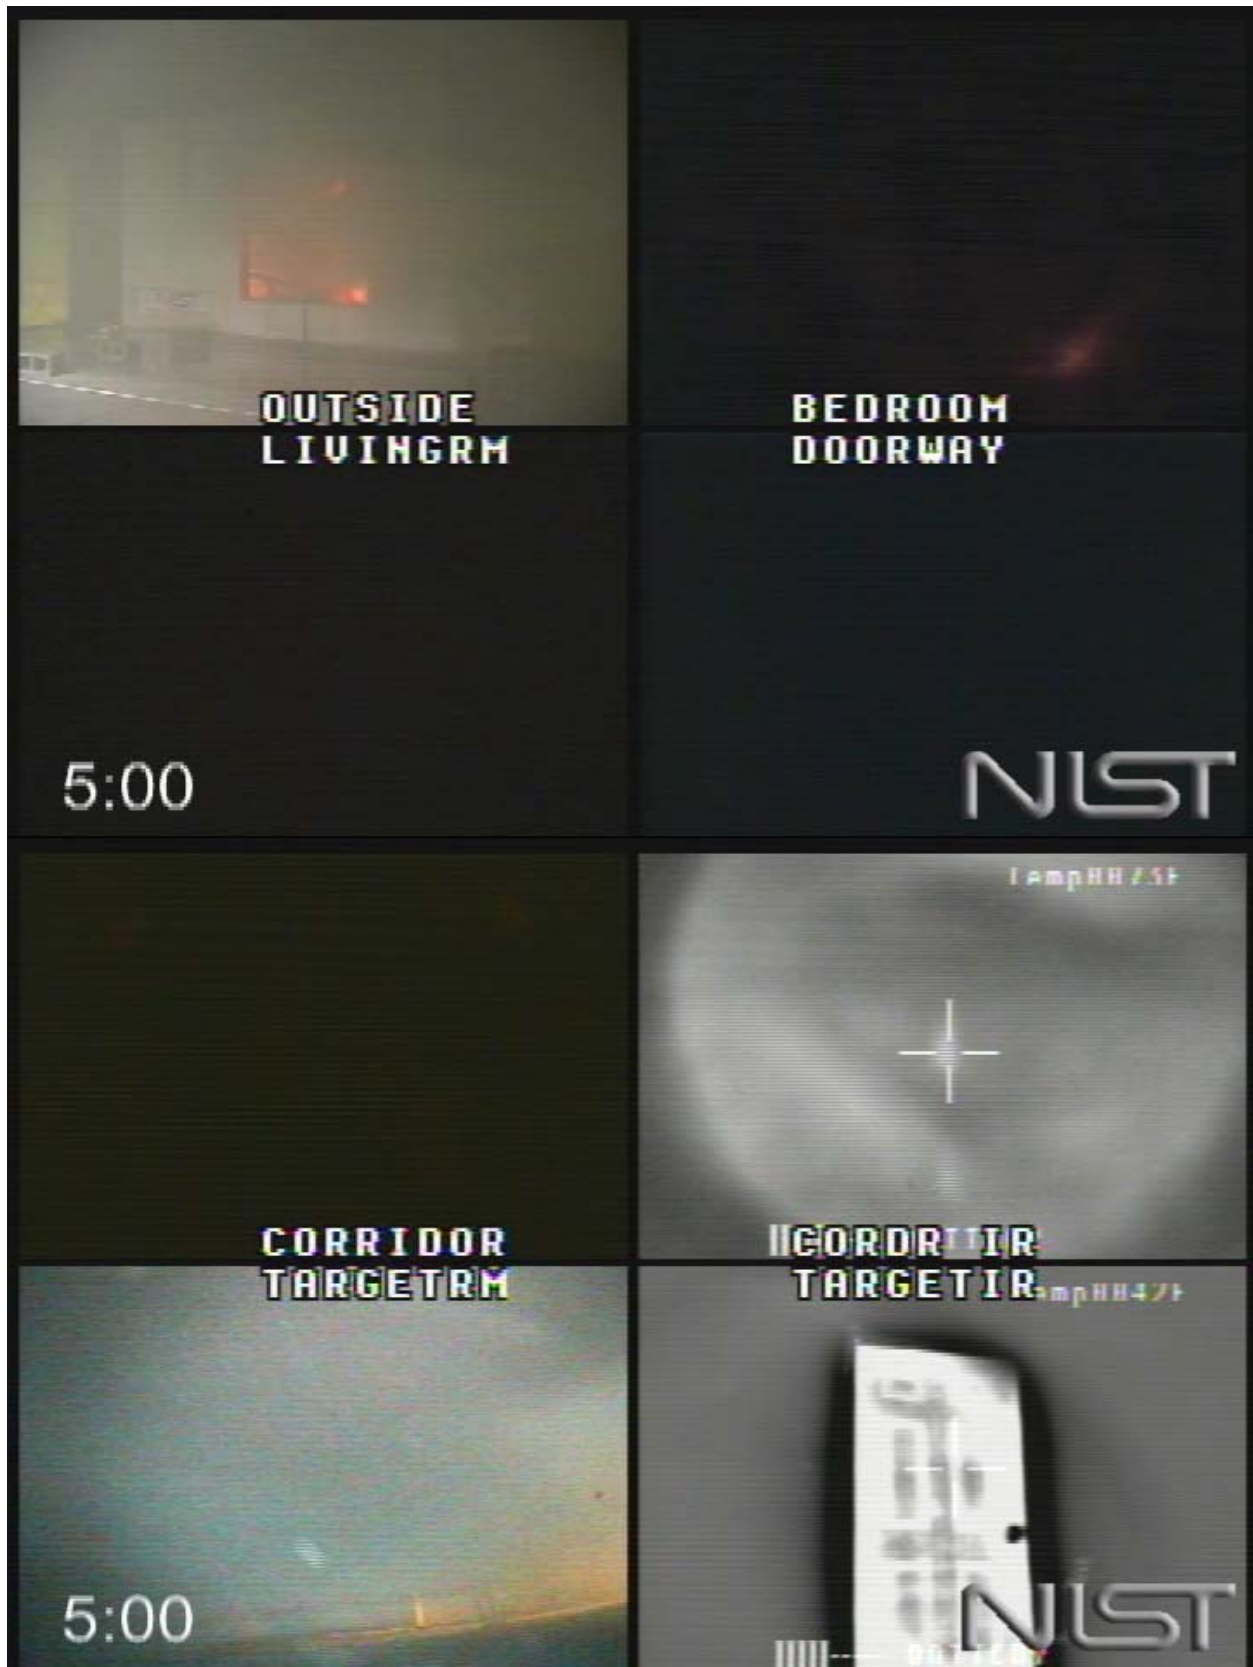
Figure 5.6.1-9. Experiment 6, 287 s after ignition, 20 s after window sprinkler activation.

At 287 s after ignition, the images in Figure 5.6.1-9 were recorded. The window sprinkler had been activated for 20 s. Flames stilled pulsed from the window opening. The flames near the window appeared to partially blocked by soot. The interior video views were still obscured, only a glow was visible in the bedroom view. The thermal view of the corridor was obscured due to high thermal conditions. Conditions in the target room had decayed as the hot gas layer dropped within 0.30 m (1 .0 ft) of the floor. Flames were still visible under the door to the hallway. In the thermal image of the target room door, the door had become whiter in color, indicating that had become hotter.

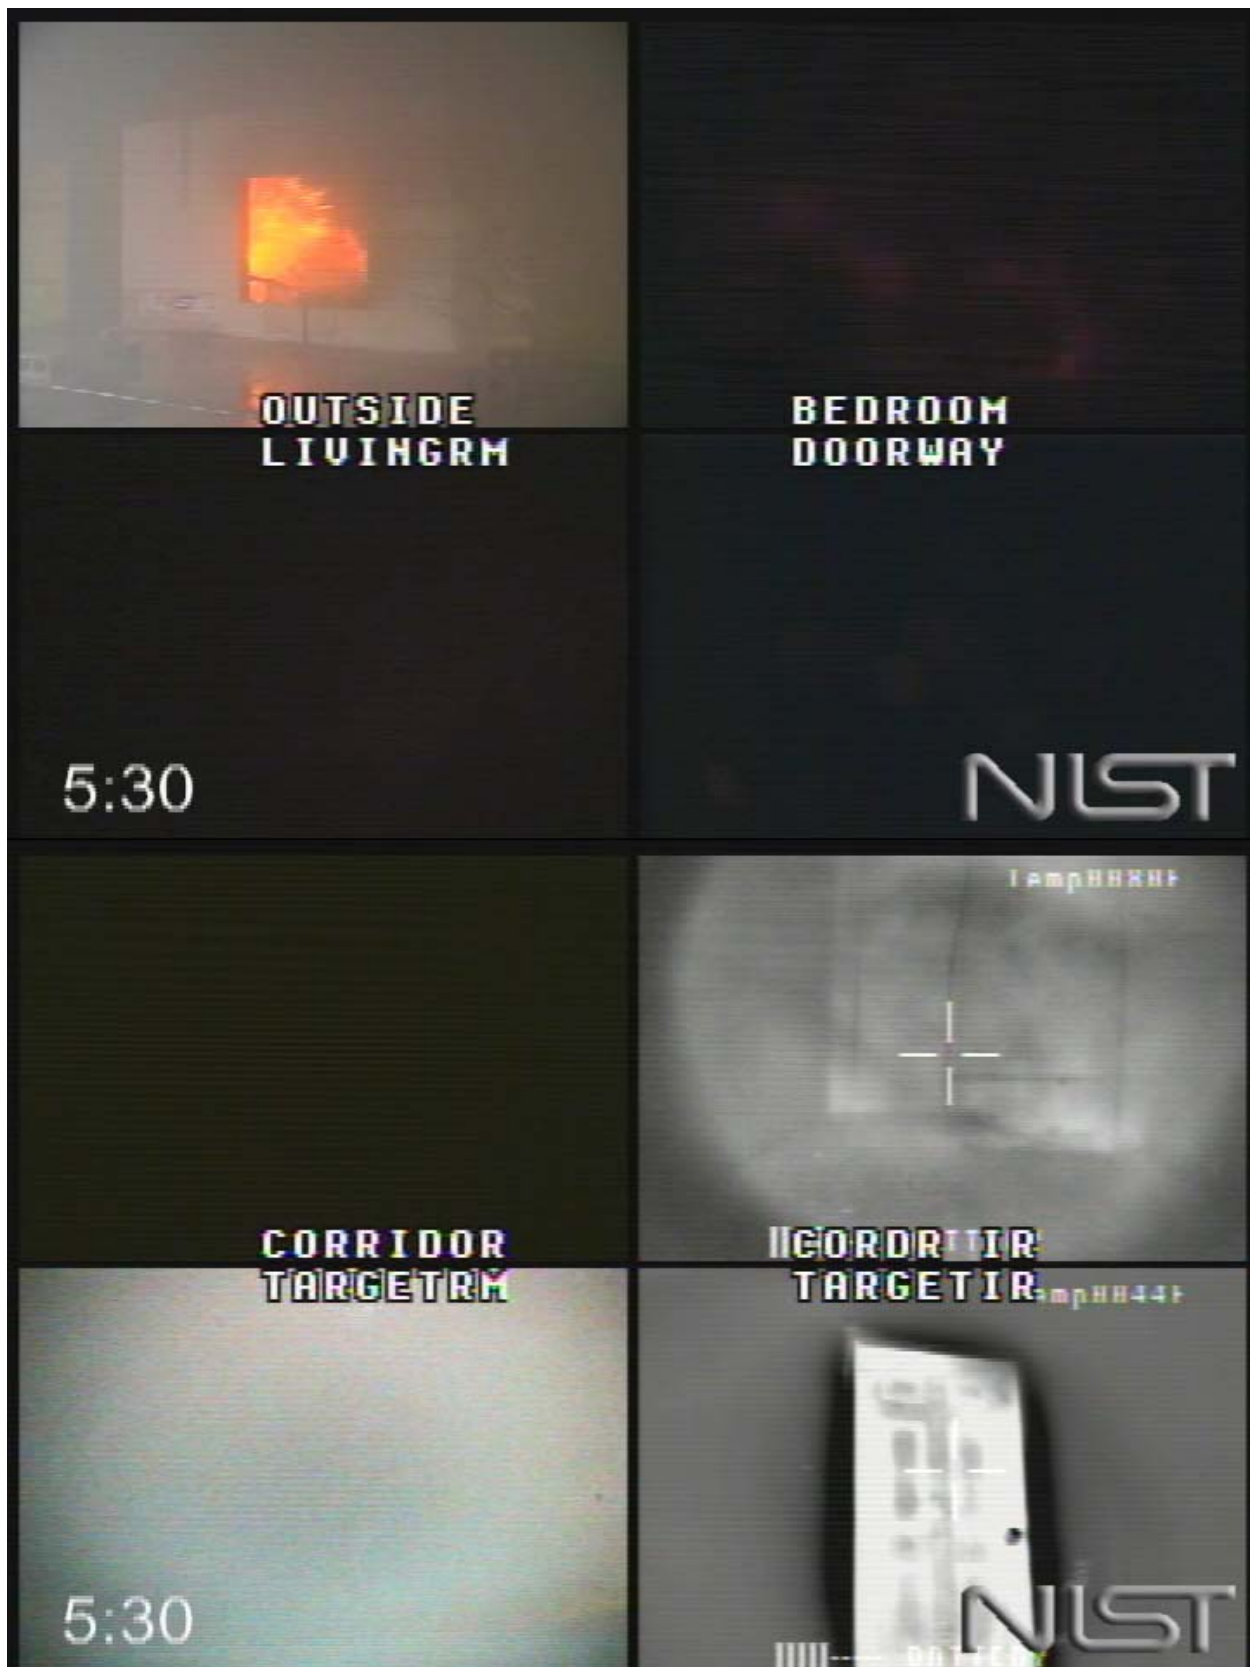
Figure 5.6.1-10. Experiment 6, 300 s after ignition.

Figure 5.6.1-10 shows the conditions at 300 s after ignition, or approximately 8 s after the water fog was started across the window opening. The interior video views were still obscured by smoke. The thermal image from the corridor was still saturated due to high heat conditions. In the target room, the smoke layer was near the floor, flames were no longer visible coming under the door. The door continued to heat up, as shown in the target room thermal view.

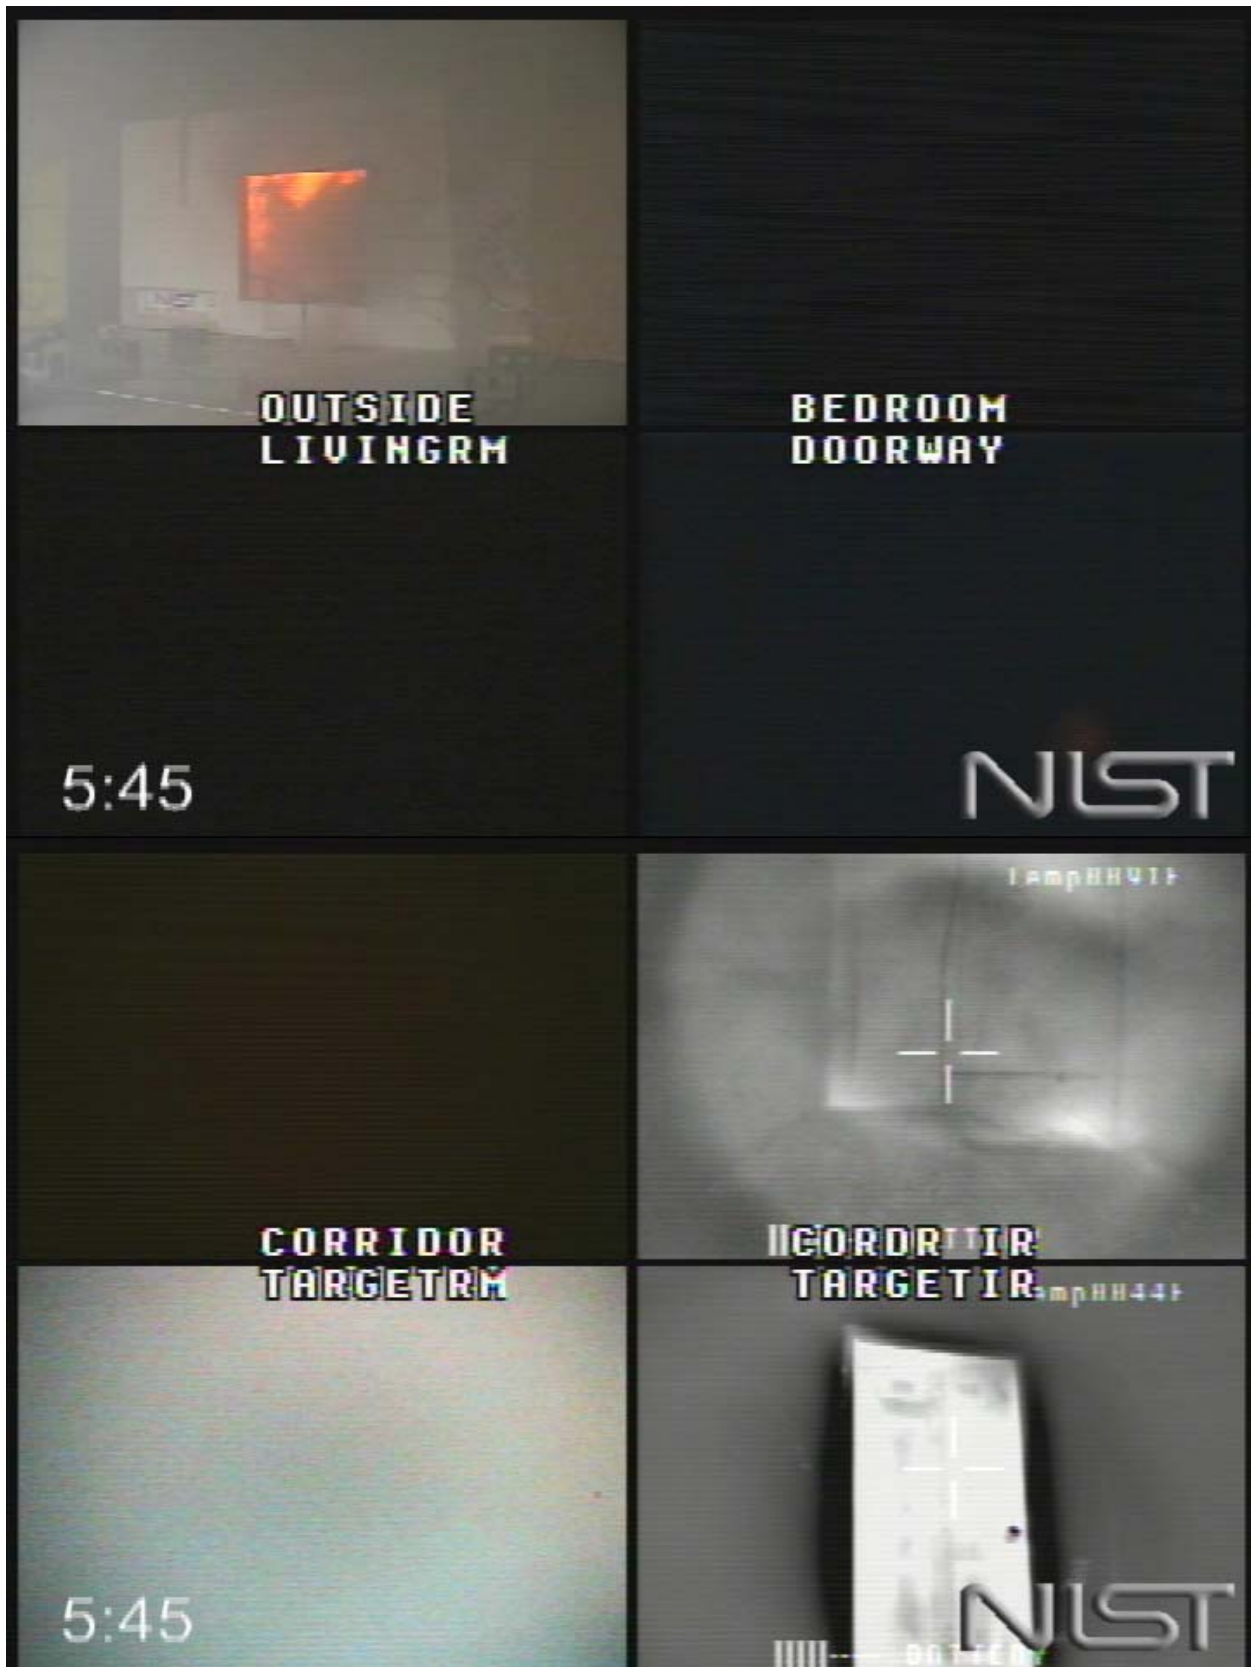
Figure 5.6.1-11. Experiment 6, fog stream across window off, 330 s after ignition.

Figure 5.6.1-11 shows the conditions at 330 s after ignition, just as the fog water was shut off. The window sprinkler was still activated. The area in the center of the window opening was free from fire.

All of the interior video views were still obscured by soot. The corridor thermal image shows more contrast indicating that the thermal conditions in that location had cooled. The target room thermal image shows that the door remained hot.

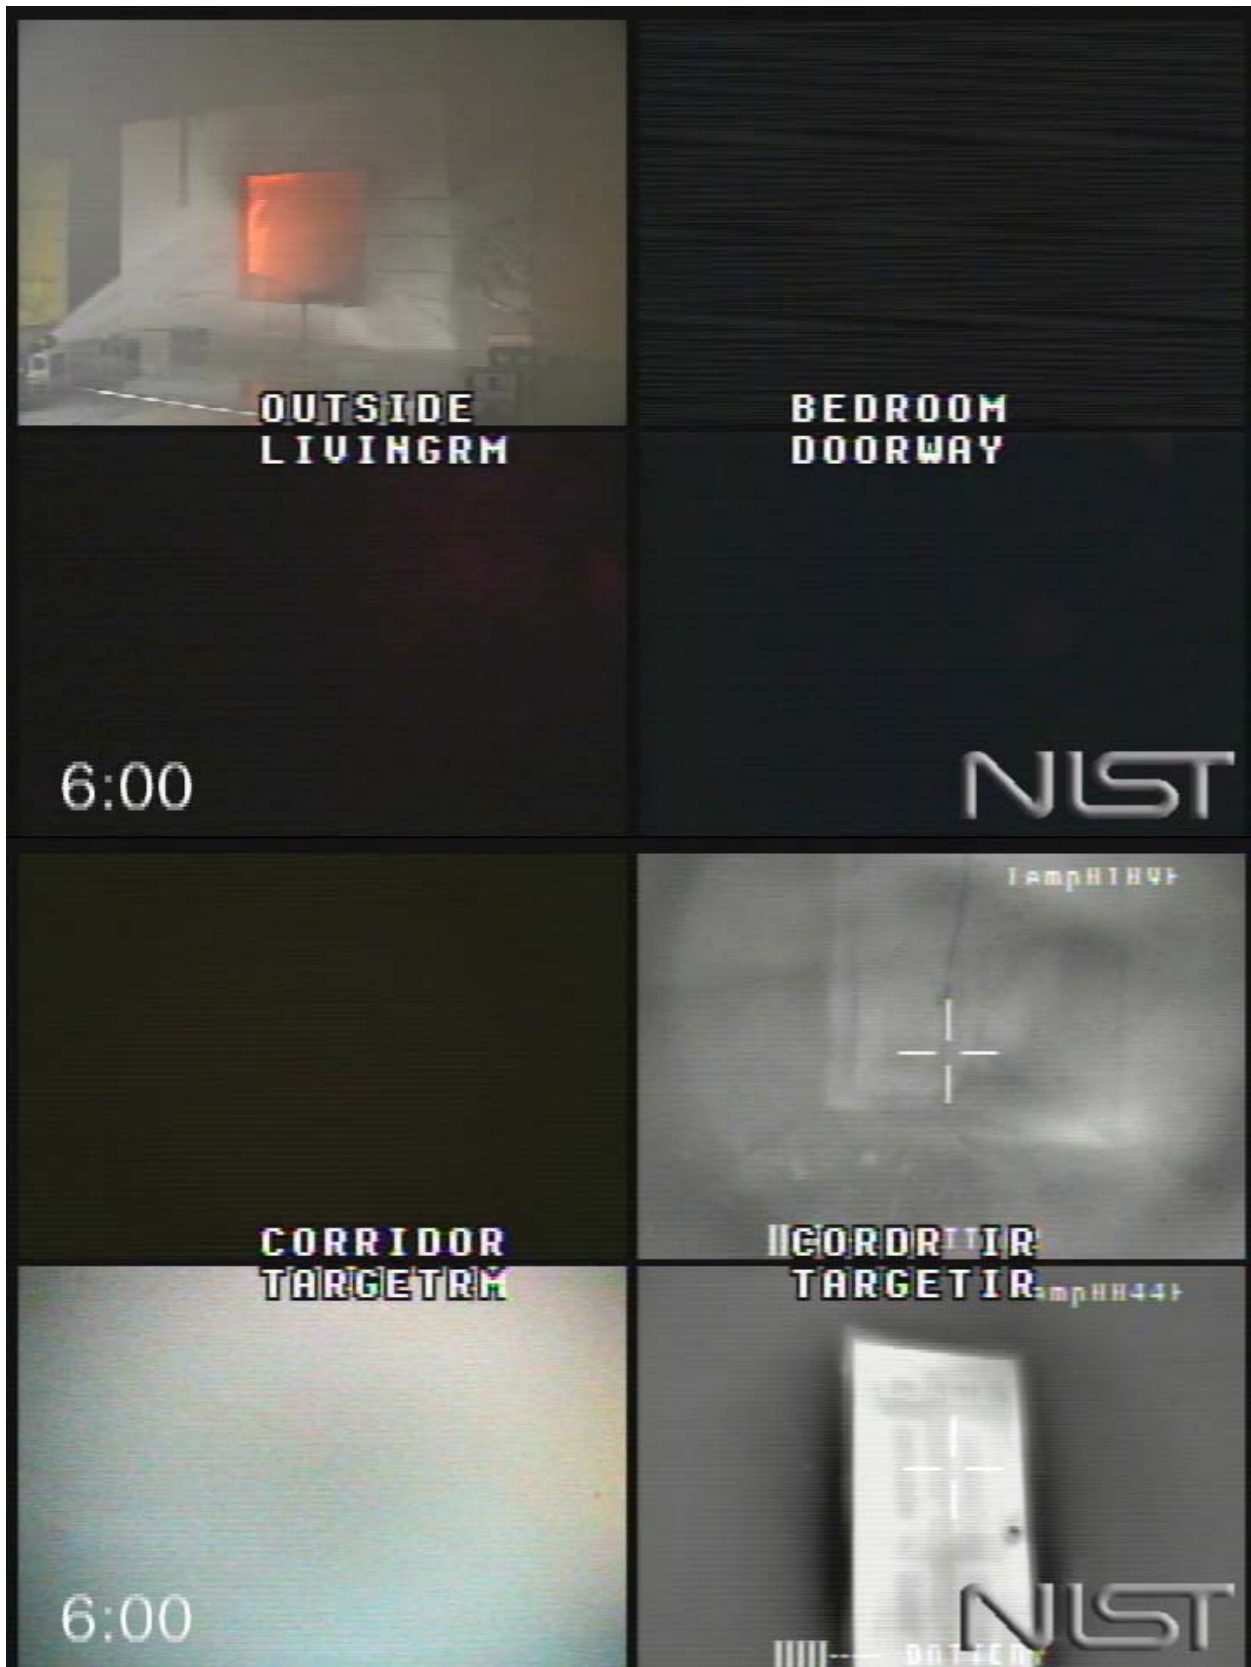
Figure 5.6.1-12. Experiment 6, direct fog stream on, 345 s after ignition.

The images in Figure 5.6.1-12 were recorded at 345 s after ignition, just prior to the activation of the fog stream into the window opening. The volume of flame visible through the window opening had decreased. All of the interior video views were obscured by smoke. The thermal images showed cooler conditions in the corridor and a hotter target room door when compared with the previous figure.

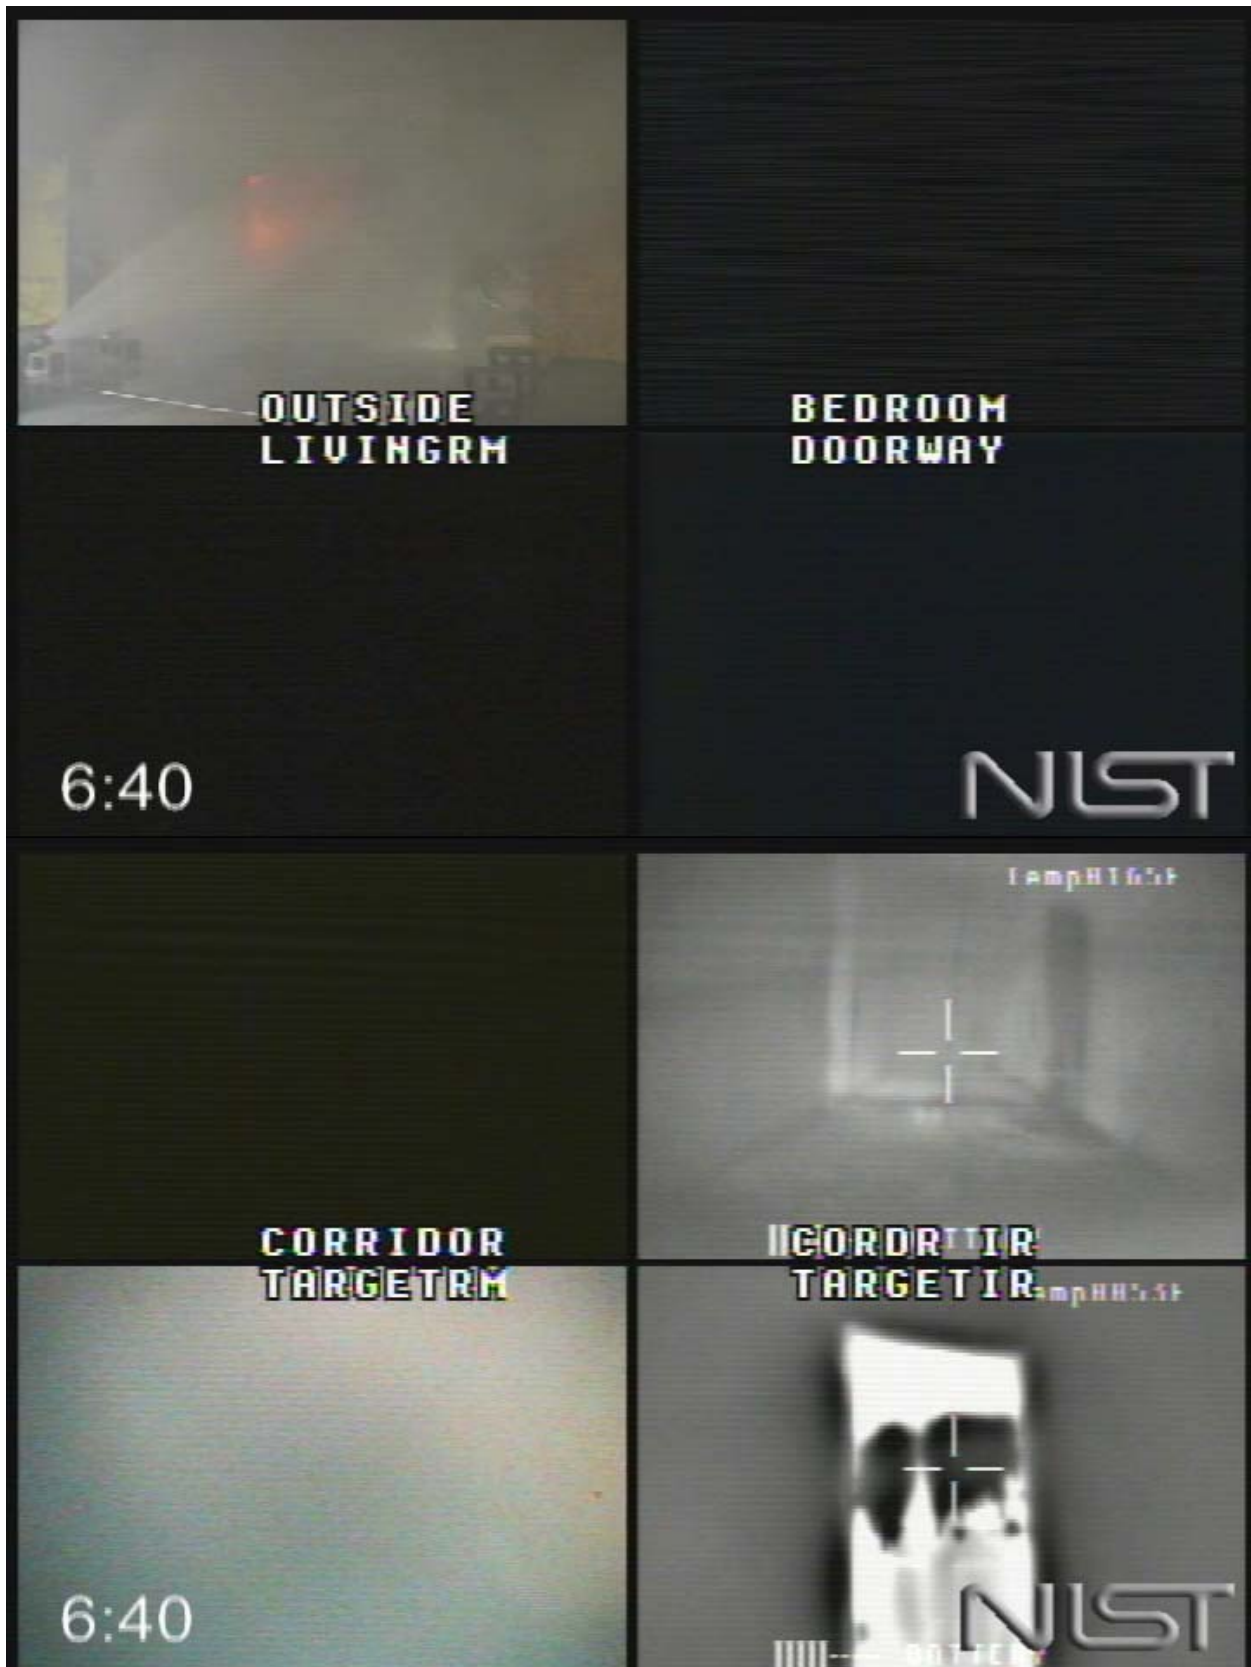
Figure 5.6.1-13. Experiment 6, 360 s after ignition.

Figure 5.6.1-13 shows the conditions 13 s after the fog spray directly into the window was started. The images seem similar to the images in Figure 5.6.1-12.

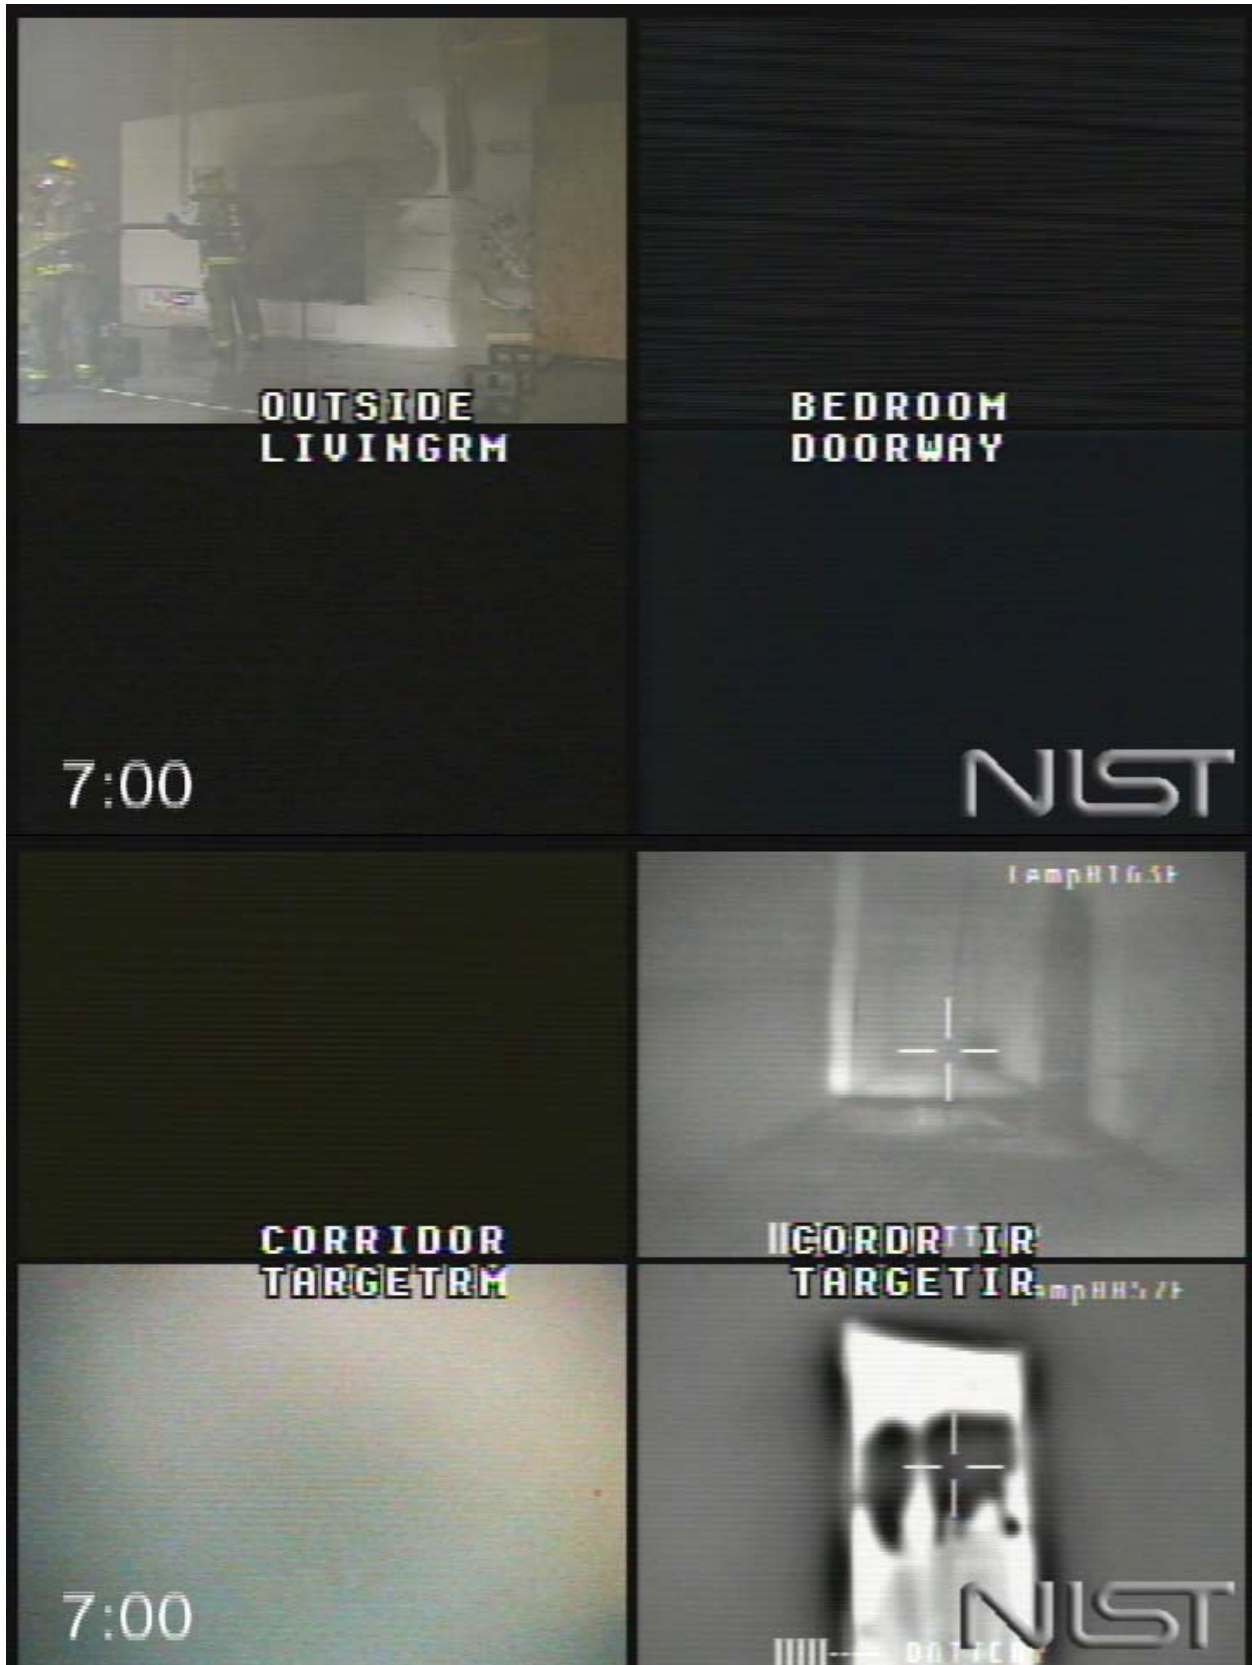
Figure 5.6.1-14. Experiment 6, 400 s after ignition.

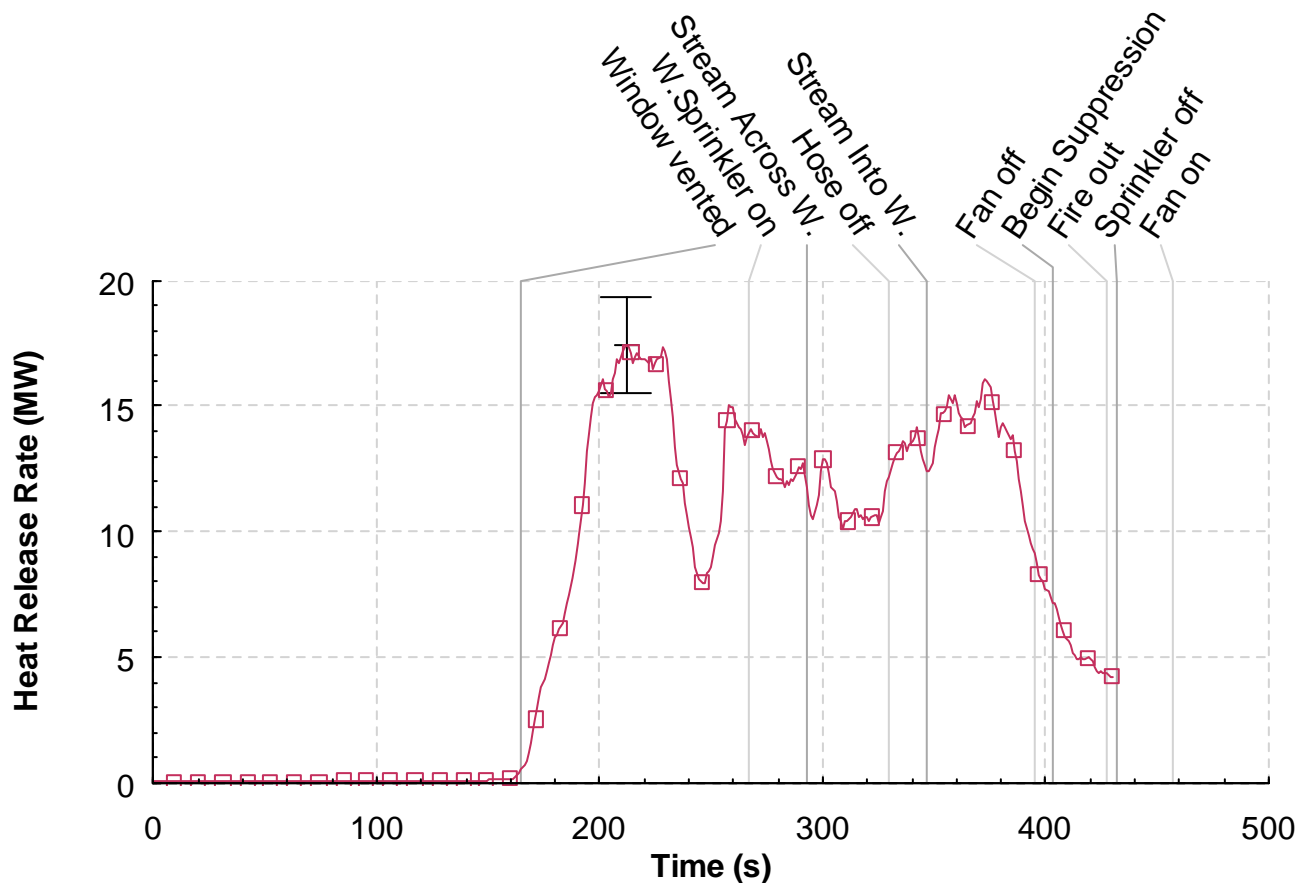
Figure 5.6.2-1. Heat release rate versus time, Experiment 6.

Figure 5.6.2-1 shows the heat release rate time history for Experiment 6. The increase in measured heat release rate is delayed because for the first 160 s after ignition because no heat or combustion products generated by the fire flowed out of the structure. After the window failed, at 165 s after ignition, the increase in heat release rate was clear. The heat release rate reached a peak of approximately 17 MW, 45 s after window failure, followed by a quick drop to 8 MW and return to 15 MW over the next 30 s. The window sprinkler was activated at 267 s and hose was sprayed across the window at 293 s which caused the heat release rate to drop to just above 10 MW. At 347 s, the hose stream was shut off, repositioned in front of the window and reactivated. This action actually increased the heat release rate to a peak of approximately 16 MW for about 30 s but ultimately caused a drastic heat release rate reduction. At 395 s, the fan was shut off and manual suppression ended the test shortly thereafter.

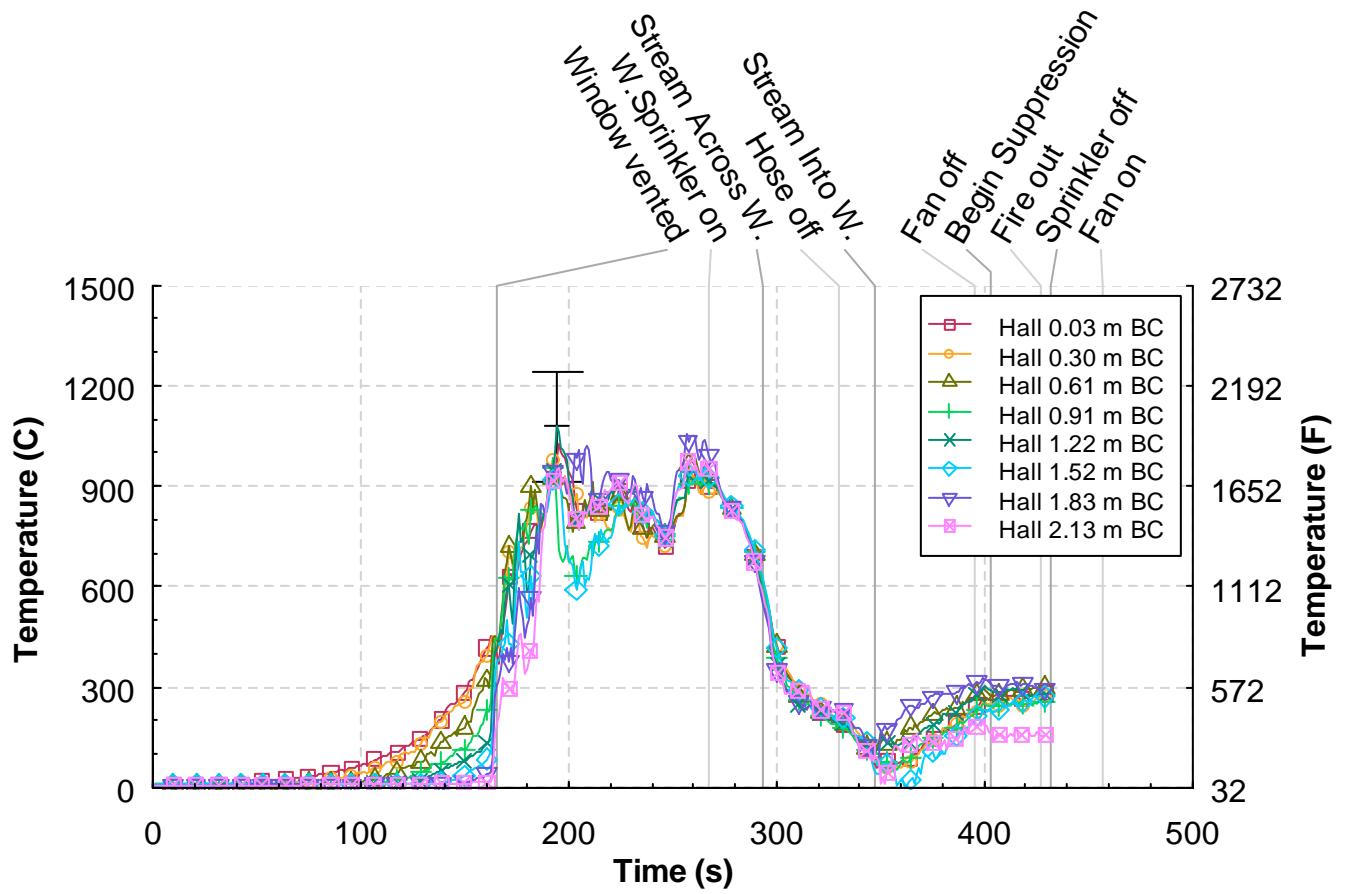
Figure 5.6.3-3. Temperature versus time from the hall thermocouple array, Experiment 6.

The data from the hall thermocouple array is presented in Figure 5.6.3-3. The temperatures slowly increased and stratified as the fire in the bedroom developed. The ceiling temperature in the hallway reached approximately 350 °C (662 °F), while the temperature 2.13 m (7.00 ft) below the ceiling was still ambient just prior to window failure. 30 s after window failure the temperatures peaked to 950 °C (1742 °F) at the ceiling, but then decreased for 50 s. At 250 s, all temperatures returned to the peak level until the window sprinkler was activated. The window sprinkler, combined with the fog stream across the window cut all temperatures down to 50 °C (122 °F). When the hose stream was redirected into the window, temperatures restratified and began to increase up to 300 °C (572 °F) in the upper layers of the hallway.

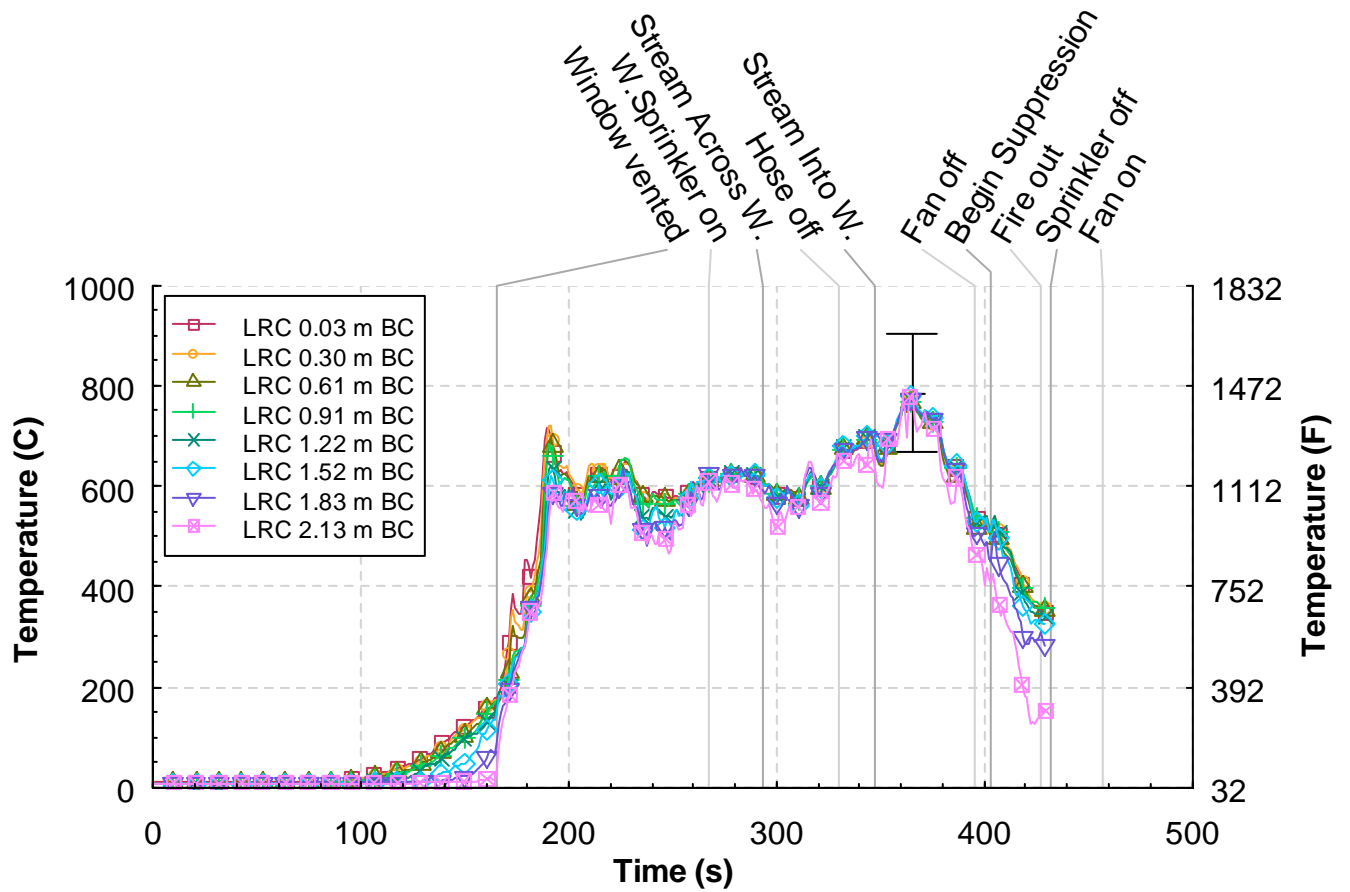
Figure 5.6.3-4. Temperature versus time from the living room corner (LRC) thermocouple array, Experiment 6.

The data from the living room corner thermocouple array is shown in Figure 5.6.3-4. 20 s after window failure, the temperatures from floor to ceiling were in excess of 600 °C (1112 °F). No significant change in temperature conditions were noted with the use of the window sprinkler or the fog stream across the window. When the hose stream was directed into the window, temperatures in the hallway increased to just below 800 °C (1472 °F) for 20 s but then fell below 400 °C (752 °F) prior to the end of the test.

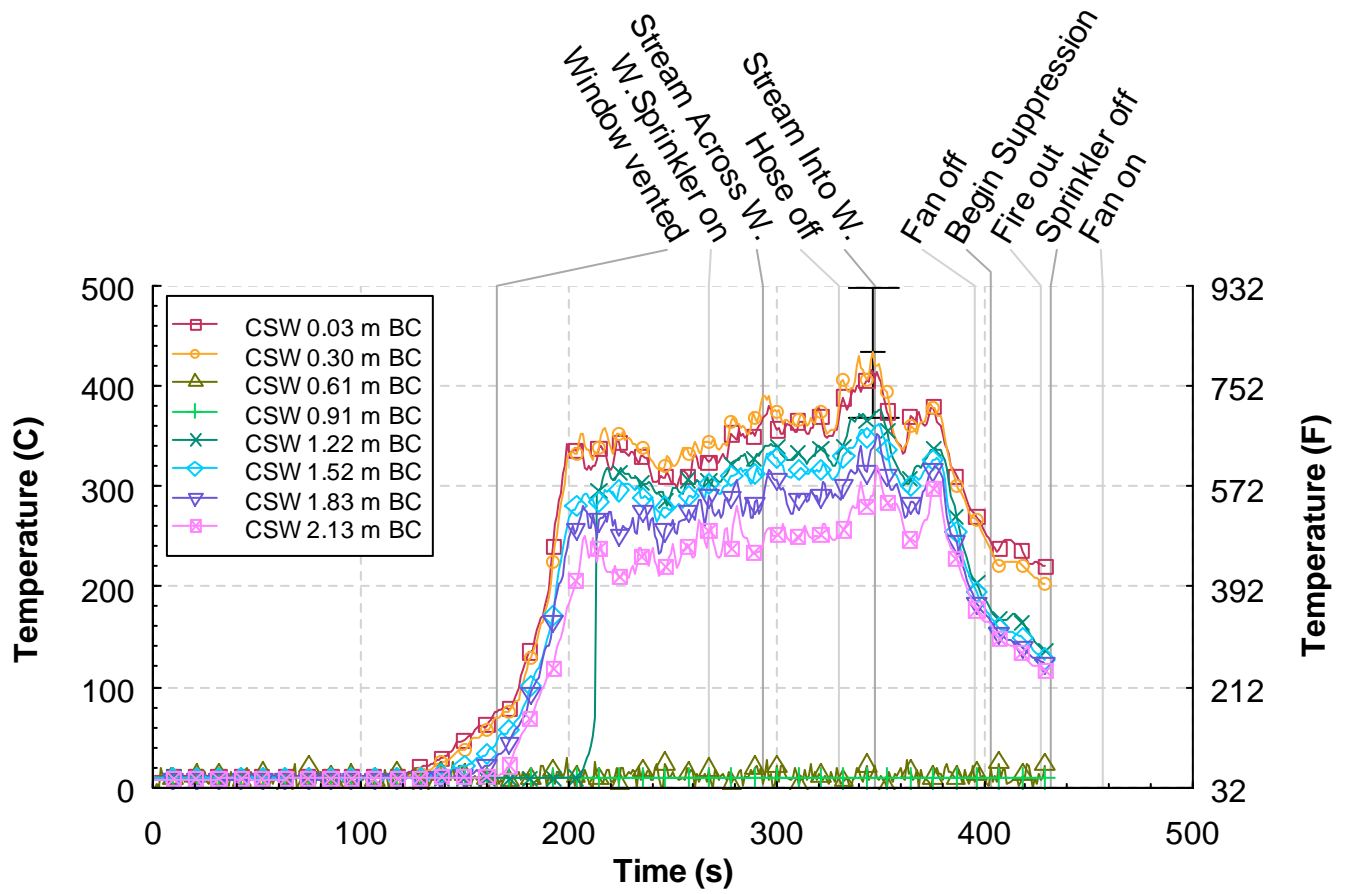
Figure 5.6.3-6. Temperature versus time from the corridor center (CC) thermocouple array, Experiment 6.

Figure 5.6.3-7. Temperature versus time from the corridor south (CS) thermocouple array, Experiment 6.

Figure 5.6.3-8. Temperature versus time from the corridor southwest (CSW) thermocouple array, Experiment 6.

Figure 5.6.3-9. Temperature versus time from the corridor north (CN) thermocouple array, Experiment 6.

Temperature conditions in the corridor are given in Figure 5.6.3-6 through Figure 5.6.3-9. Temperature records for the center and north corridor regions were similar in nature but were slightly different in scale. The center and north regions peaked at 800 °C (1472 °F) 30 s after window failure then reduced in temperature 600 °C (1112 °F). Window sprinkler activation and the fog stream application across the window steadily increased temperatures up until the fog stream was redirected into the window but the center region topped out at 800 °C (1472 °F) while the north region hit 950 °C (1742 °F). Fog stream application into the window significantly decreased temperatures in both regions throughout the remainder of the test. The south and southwest regions of the corridor both rapidly increased in temperature 30 s after window failure with the south reaching 600 and southwest reaching 350 at the ceiling. Both regions were more stratified in nature and declined slightly or remained relatively constant until the fog stream was directed into the window. The window sprinkler and fog application across the window did not have a significant effect on temperature differences. Directing the fog stream into the window increased both the south and southwest corridor regions for approximately 10 s before all temperatures declined to the end of the test.
